Facility Assessment for the Industrial Area Reuse Study

**Rocky Flats
Environmental Technology Site**

April 6, 1998

Prepared by:
Higginbotham/Briggs & Associates
540 North Cascade Avenue, Suite 300
Colorado Springs, CO 80903-3392
Architects & Planners

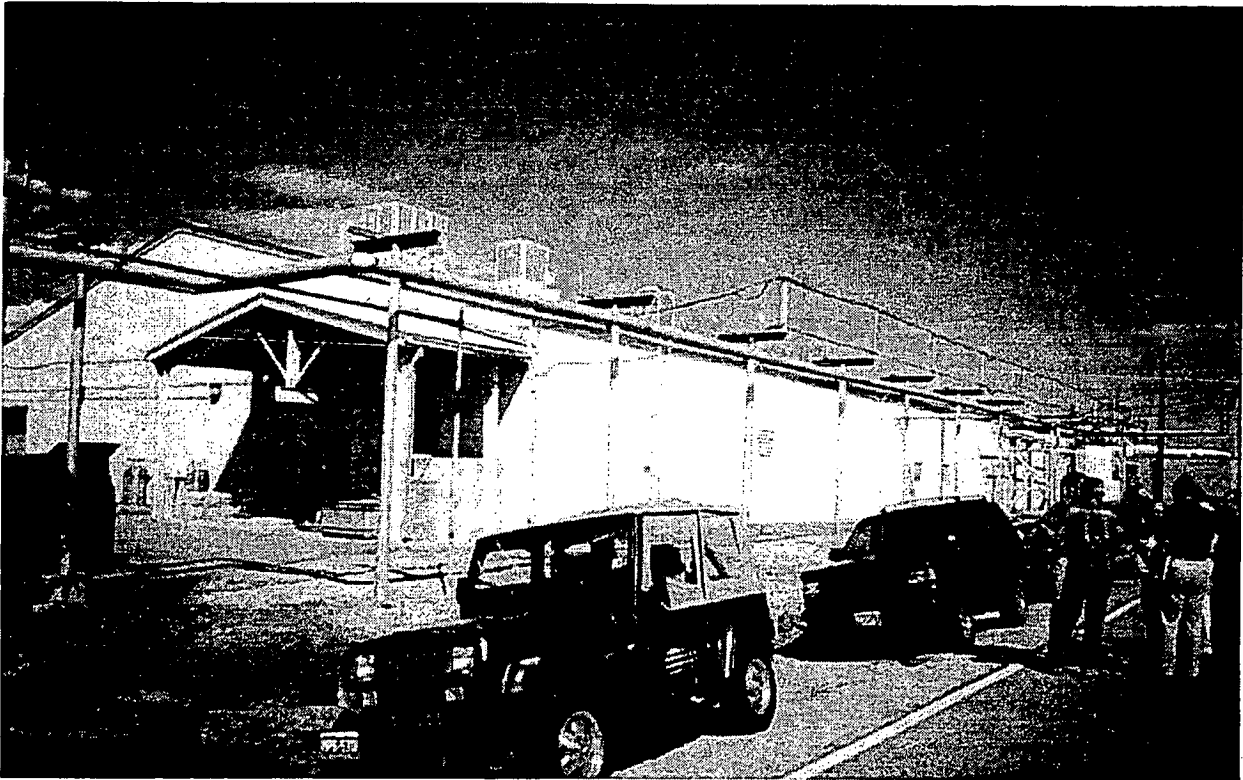
Building 125 - View from Southeast

1. Location: Building 125 is located just east of Parking Area 12 and west of the intersection of Third Street and Cottonwood.
2. Description: It is the Standards Metrology Laboratory, where measuring and timing instruments are calibrated. The facility is a single-story, metal frame building with metal siding and sloped metal roof with overlay. It was built in 1965 (with two subsequent additions) and contains 12,900 SF. It is presently occupied by 15 personnel but has a capacity of approximately 50. It contains several stainless steel, prefabricated laboratory modules that are climate controlled, one of which is also seismically isolated.
3. Future Usability:
 - Assumed Reuse: Standards or calibration lab.
 - Assets: Modular lab areas.
 - Liabilities: Age, energy inefficiency, lack of independent heat source.

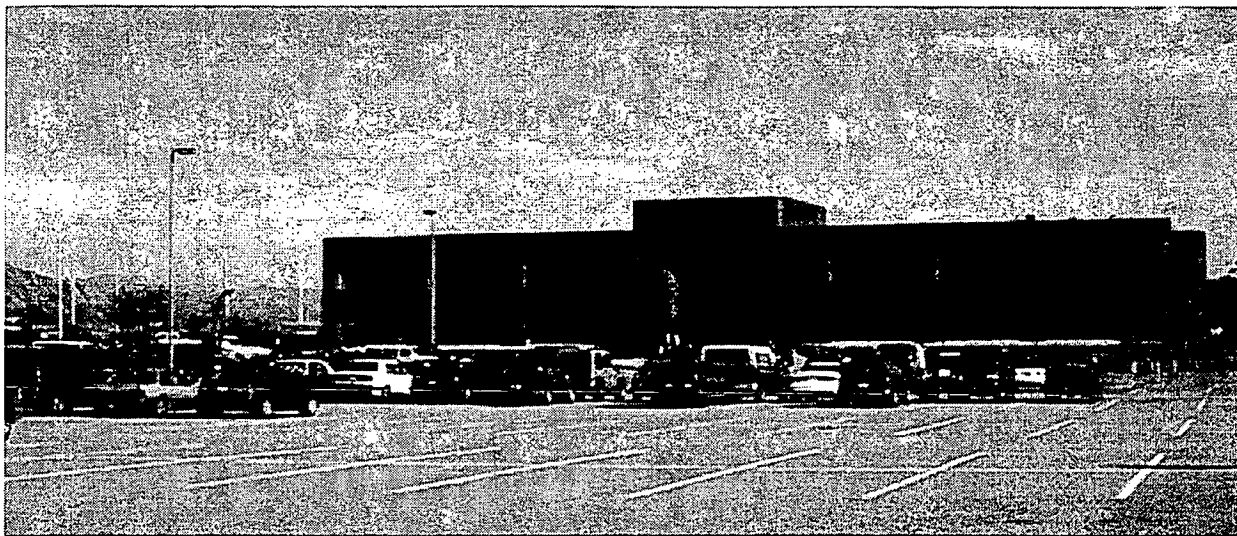
Building 130 - View of South Elevation

- **Assets:** Relatively young age, flexible floor plan (central core with "racetrack" corridor and large open office areas), stand-alone HVAC system (although in poor condition - see below - not dependent on steam system).

- **Liabilities:** Inefficient and marginally functional HVAC system (series of small boilers tied to non-functional solar panels and evaporative cooling).

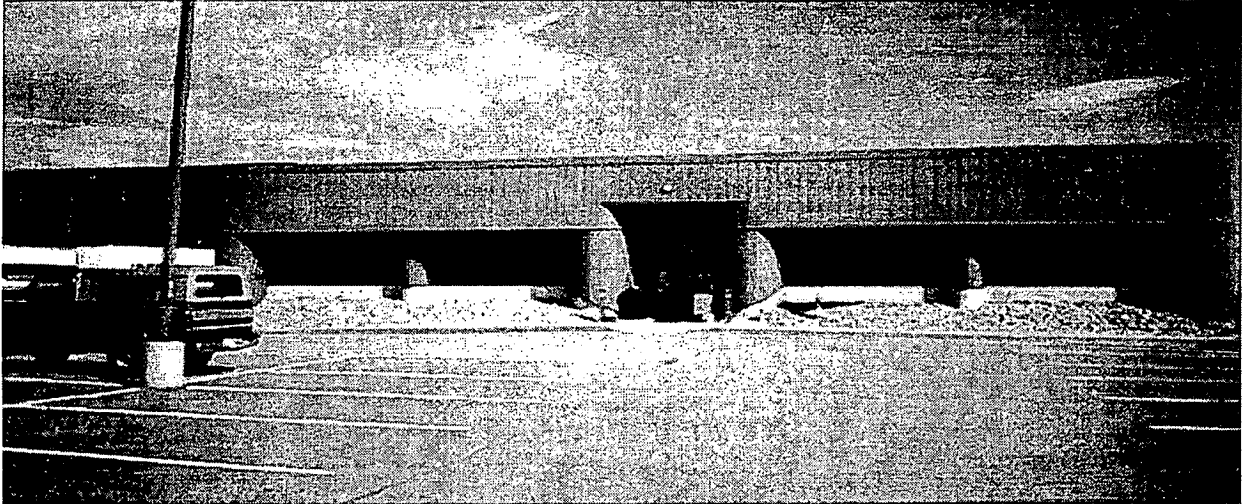
Building 131 - View from South

1. Location: Building 131 is located on the east side of the Building 130W about 300 feet north of West Access Road and just west of First Street.
2. Description: It is a one story, 22,000 SF general office building, built in 1986. This facility has a steel frame with anodized aluminum siding similar in color to the skin of Buildings 130 and 130W and a standing seam, sloped metal roof. Landscaped (mostly gravel) earth berms surround the building to about the sill level. It has a rated occupancy of approximately 121 people.
3. Future Usability:
 - Assumed Reuse: General office.
 - Assets: Relatively young age, stand alone HVAC system, flexible floor plan (almost entirely open office areas or demountable partition enclosed offices with a small core area with restrooms, etc.).
 - Liabilities: None known.

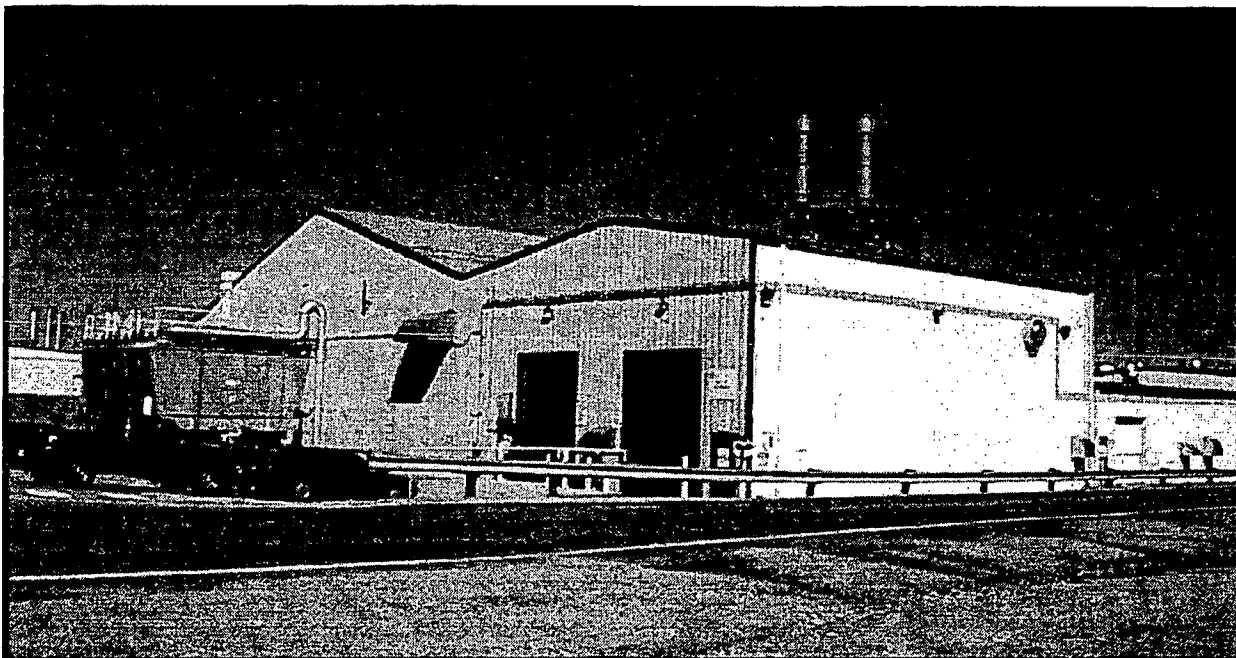
Building 440 - View from Southwest

1. Location: Building 440 is located just northeast of the intersection of Fourth Street and Cactus Avenue in the south-central portion of the Industrial Area.
2. Description: It is a railcar and truck modification facility constructed in 1971. This facility, containing 34,320 SF, is a single story steel framed, metal-sided and roofed building with an elevated center rail bay. It has a small amount of interior office space.
3. Future Usability:
 - Assumed Reuse: Warehouse or manufacturing.
 - Assets: Rail siding, high bay with traveling crane.
 - Liabilities: Age, energy inefficiency, lack of independent heat source.

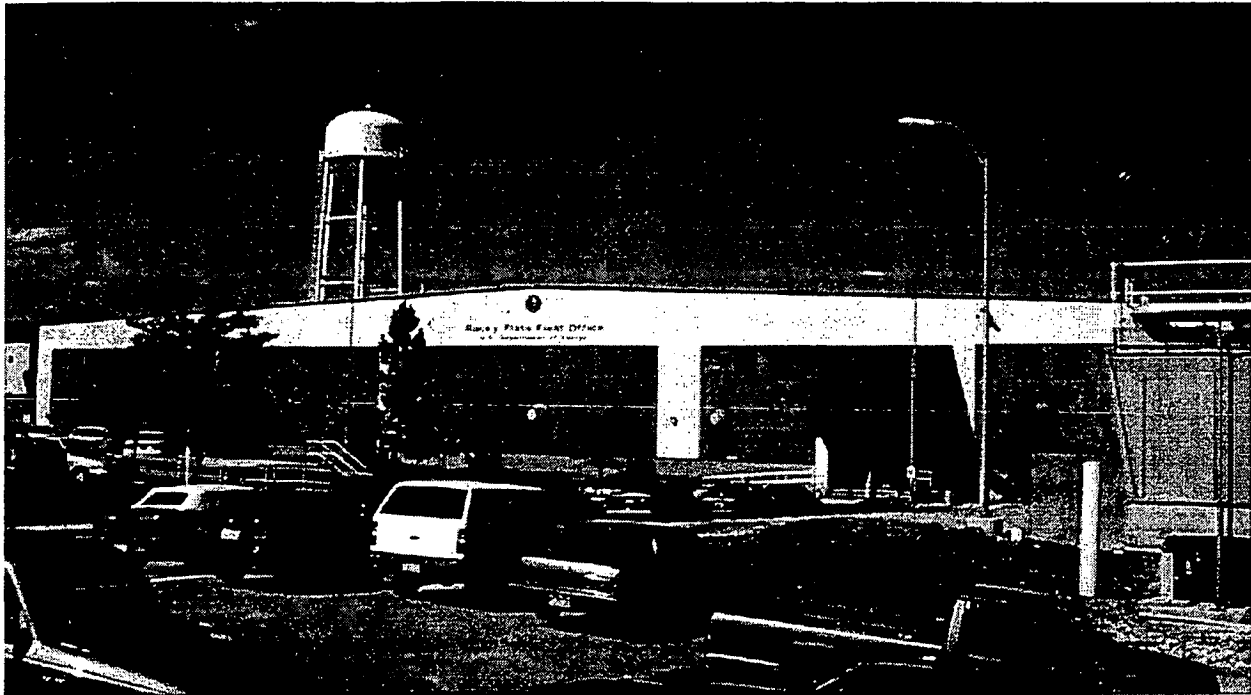
Building 460 - View from South/Southeast

3. Future Usability:
 - Assumed Reuse: Manufacturing and associated administrative functions.
 - Assets: Relatively young age, enhanced power supply, high bay manufacturing area, high capacity flooring, loading docks.

- Liabilities: Lack of independent heat source, difficult truck circulation due to nearness of Building 444 to the east (if 444 is demolished, excellent truck circulation could be easily accomplished).

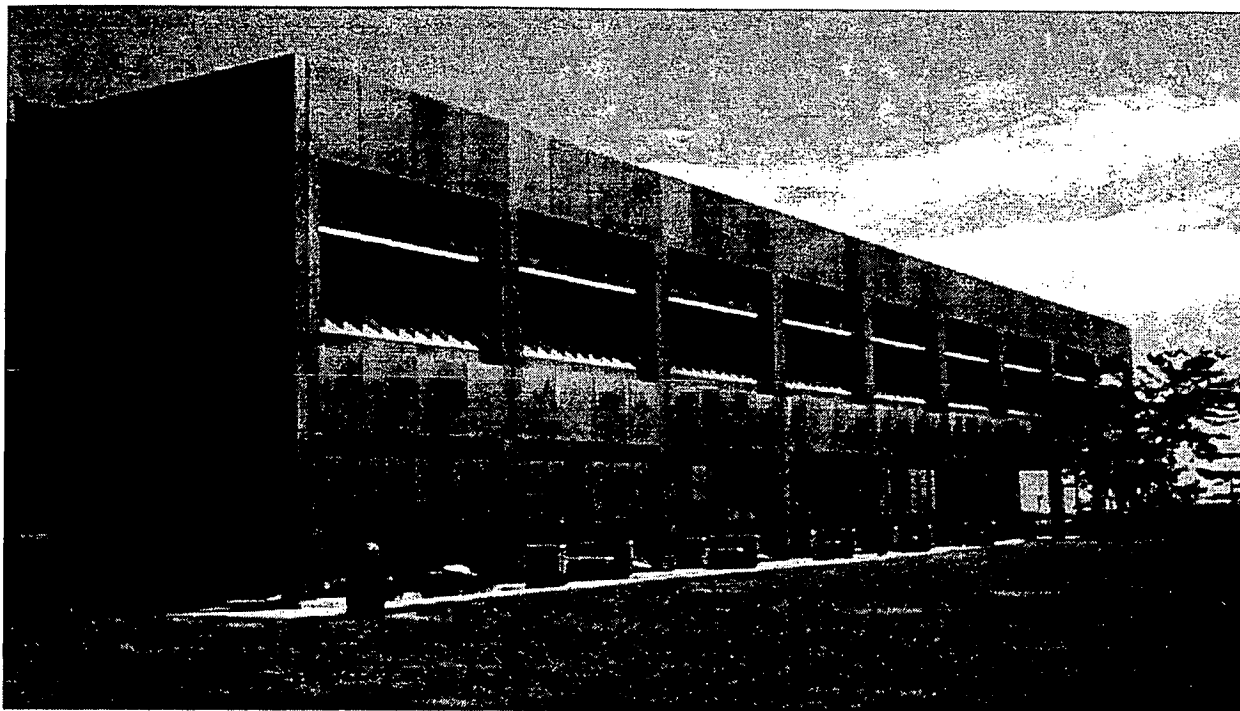
Building 850 - View from Southwest

1. Location: Building 850 is located east of Seventh Street and Parking Area 850 and north of Cactus Avenue in the south central part of the Industrial Area.
2. Description: It is a general office building holding a number of different organizations. The facility is a two story (with partial basement), steel frame, anodized aluminum metal-sided structure with a flat, modified bitumen roof. It was constructed in 1984 and comprises a total of 39,894 SF. It has an occupancy rating of approximately 100 personnel. It contains a service-only cafeteria with an approximate 100 person seating capacity.
3. Future Usability:
 - Assumed Reuse: General office.
 - Assets: Relatively young age, flexible floor plan (two small central cores with open office areas), daylighting on second floor.
 - Liabilities: lack of independent heat source.
